Date: 25th January 2023

TECH TOOL RELEASE NOTES

Version 2.8.175

Volvo Group

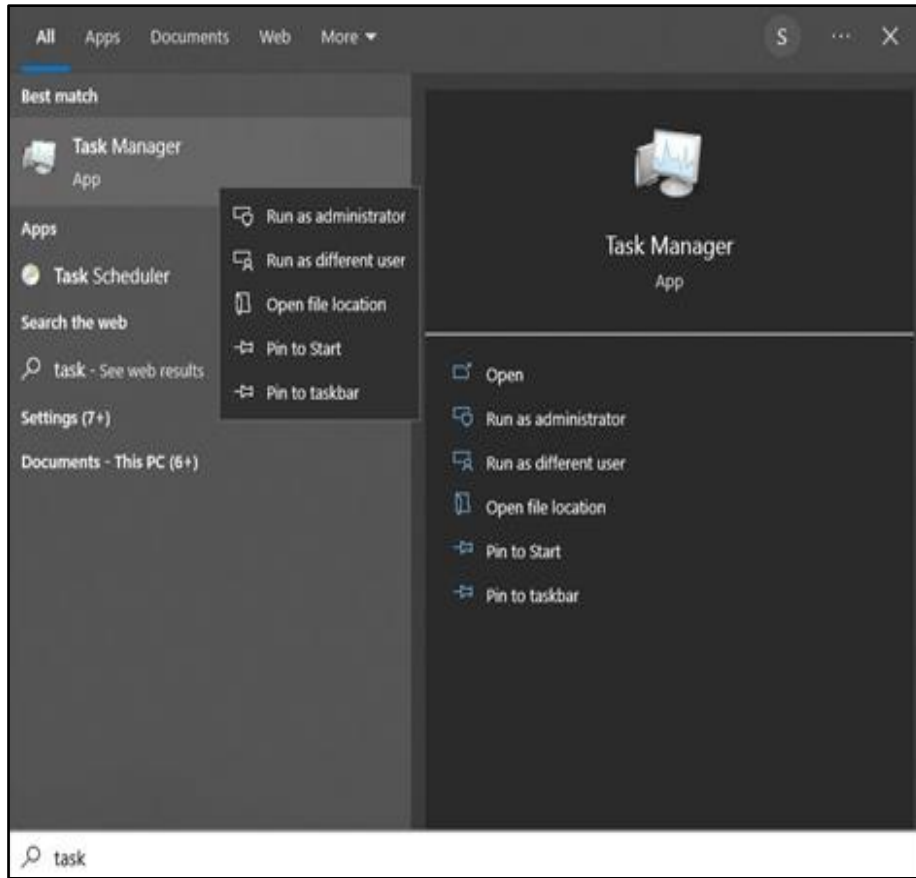
Issue-1: Tech Tool Services [Baf service] are not getting started.

Cause: When the computer is closed and enters Sleep or Hibernate mode, Tech Tool might get into the “Services not started” error.

1. We recommend changing the windows settings so that the computer does not go into Sleep or Hibernate mode. (Drawback: power consumption). Please follow the instructions stated in '[Power Settings Modification.doc](#)'.
2. If the issue occurs, restart the computer, then launch Tech Tool.
3. If not recovered, follow the below steps after restarting the computer.
 - a. Search for Task Manager in search field from task bar.
 - b. Right-click on the Task Manager.
 - c. Select “Run as administrator”. (Contact local IT team if you don't have administrator privilege)

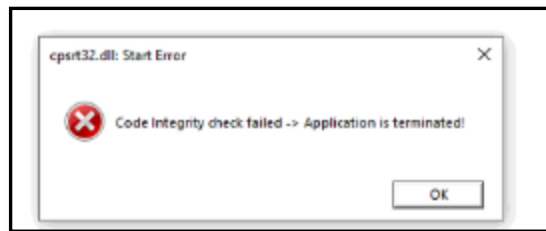
Issue-2: Code integrity check failed pop-up might be observed during the installation. Recommend staying with the currently installed version of Tech Tool.

Cause: If the user has **Cisco Secure & Trend Micro** Endpoint software installed on the computer, Tech Tool installation will fail.

1. If the user installs Tech Tool via ISO/Web, Tech Tool installation will fail.
2. If the user updates Tech Tool via Client Update, the installation will get corrupted. If installation gets corrupted, kindly contact Tech Tool support team.

Note: We recommend to disable Client Update Service to avoid automatic Tech Tool update. Information on how to disable Client Update Service is provided in the [Video](#).

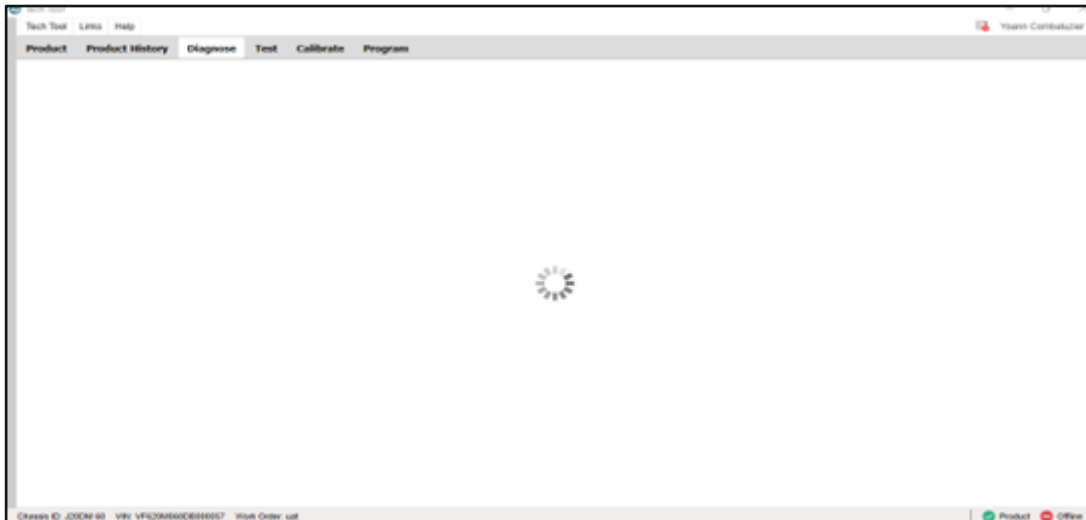
Issue-3: While switching between the tabs, Tech Tool might freeze.

Cause: Under investigation.

Suggestion: Kindly follow the below steps:

1. Ensure that there is a stable network as shown in the icon
2. Restart Tech Tool.
3. If not able to recover, restart the computer.

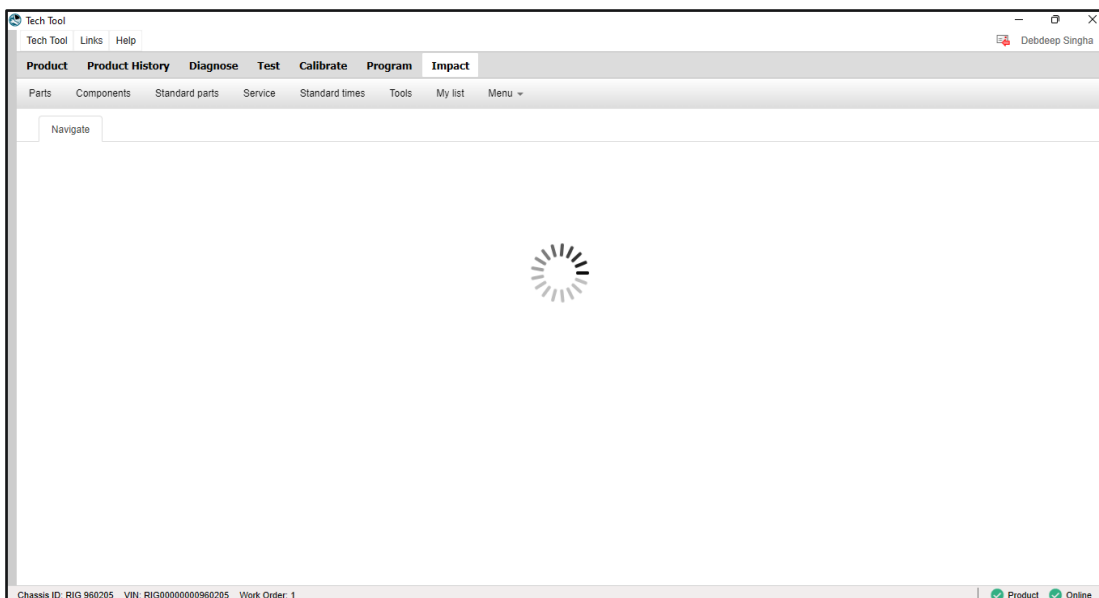
Issue-4: Impact tab not loading in Windows 11 computer.

Cause: Under investigation.

Suggestion: Open Impact tab outside Tech Tool in web browser.

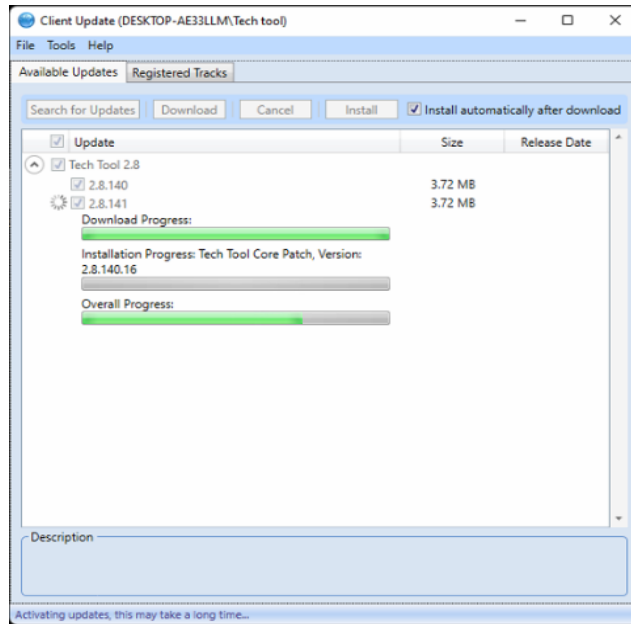
Issue-5: Tech Tool installation progress bar freeze during Client Update.

Cause: Under investigation.

Suggestion: Restart computer if the progress bar freezes for more than 30 minutes.

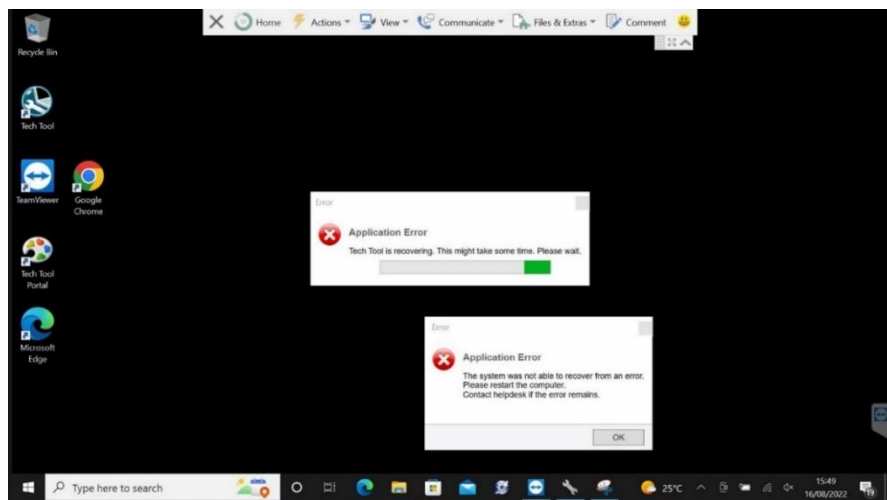
Issue-6: Application error pop-up in Tech Tool.

Cause: Under Investigation.

Suggestion: Restart Tech Tool.
